Drake TR-7 – BFO-Leakage

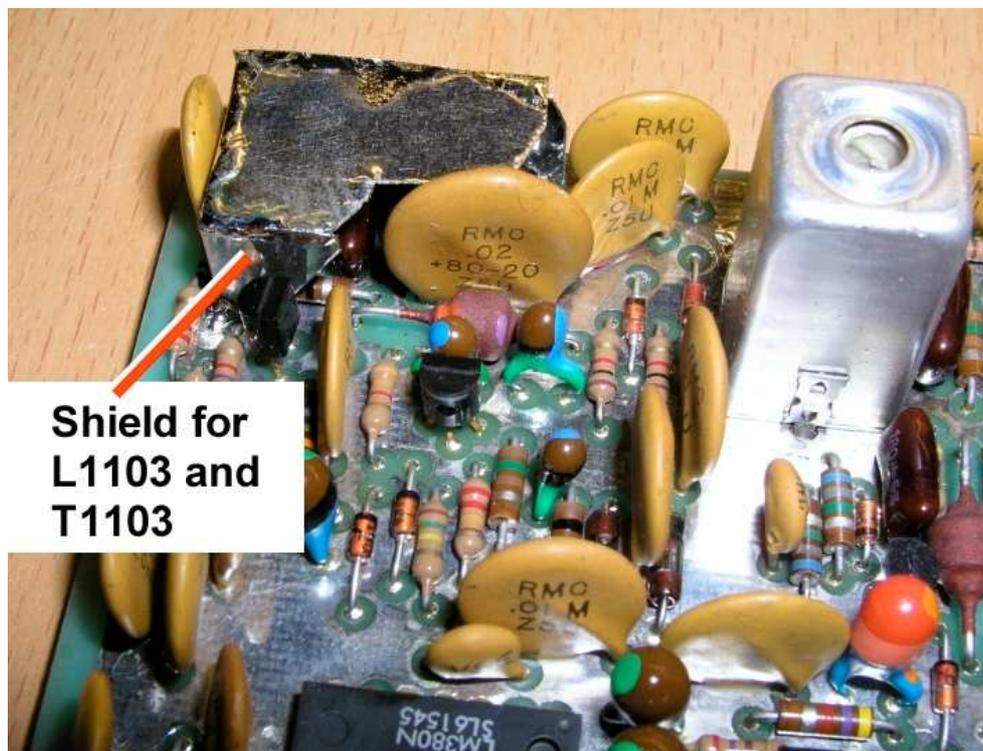
The main sources of the BFO-radiation are L1011/1012 on the PBT/Reference Board and L1103/T1103 on the 2nd IF/Audioboard.. My TR7 had no shields for these coils but the Servicemannual shows shieldings there.

Picture 1: New shield on 2nd IF/Audioboard

I made shields of metal and soldered them onto the PCB's (picture 1). It's not necessary, that the shield is completely closed, but the gaps should be as small as possible.

Solder carefully and look for good ground-contact of the shield.

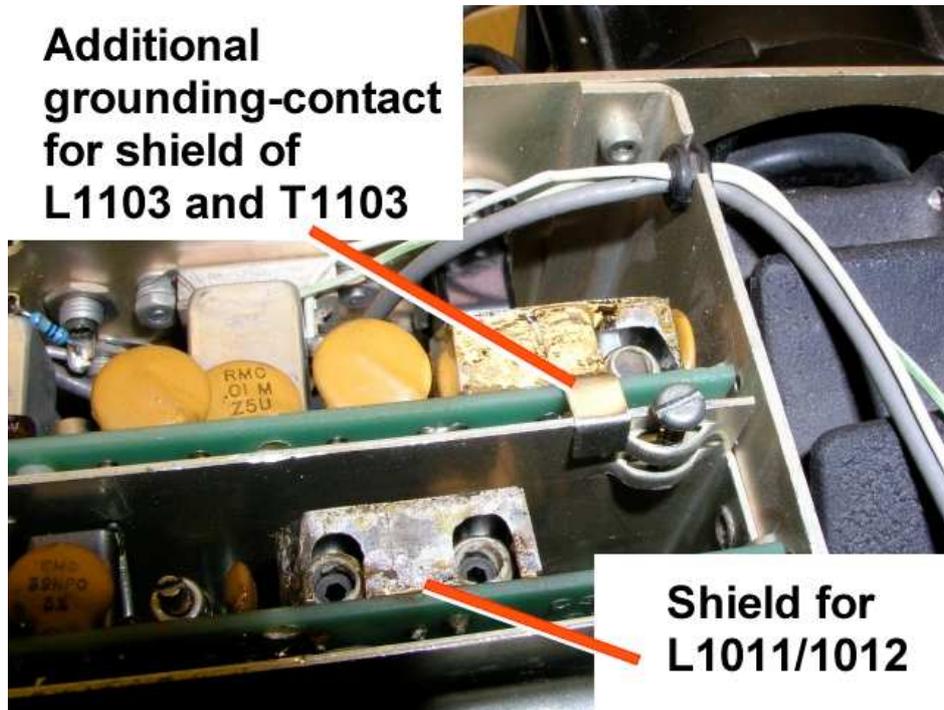
Picture 2: PBT/Reference and 2nd IF/Audio Boards

Picture 2 shows an additional ground-contact for the shield on the 2ndIF/Audioboard and the shield on the PBT/Referenceboard.

With these steps the S-Meter dropped down from over S9 down to approximately S3 to S4 without the top-cover!

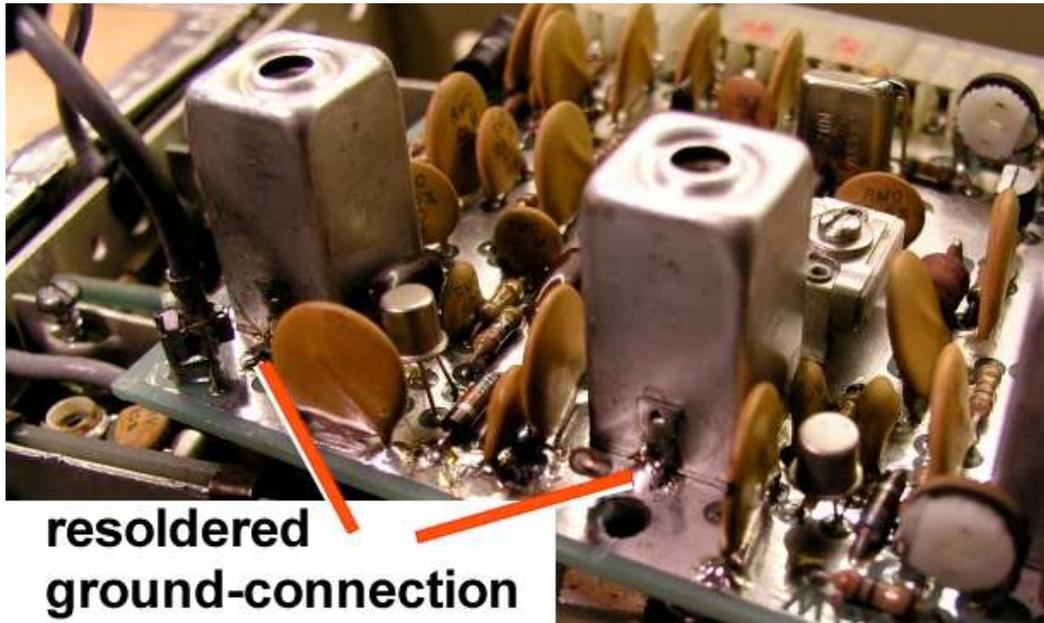
The most sensitive stage for coupling with the BFO-signal is the first amplifier on the 2ndIF; it's T1101/Q1101. In the first step, I resoldered all ground-connections of the coil-shields (pictures 3 to 5). For this purpose, it's necessary to remove temporarily some components (picture 4).

Picture 3: Groundconnection for coil-shields

This step improved the situation only a little bit; but another step helped much more:

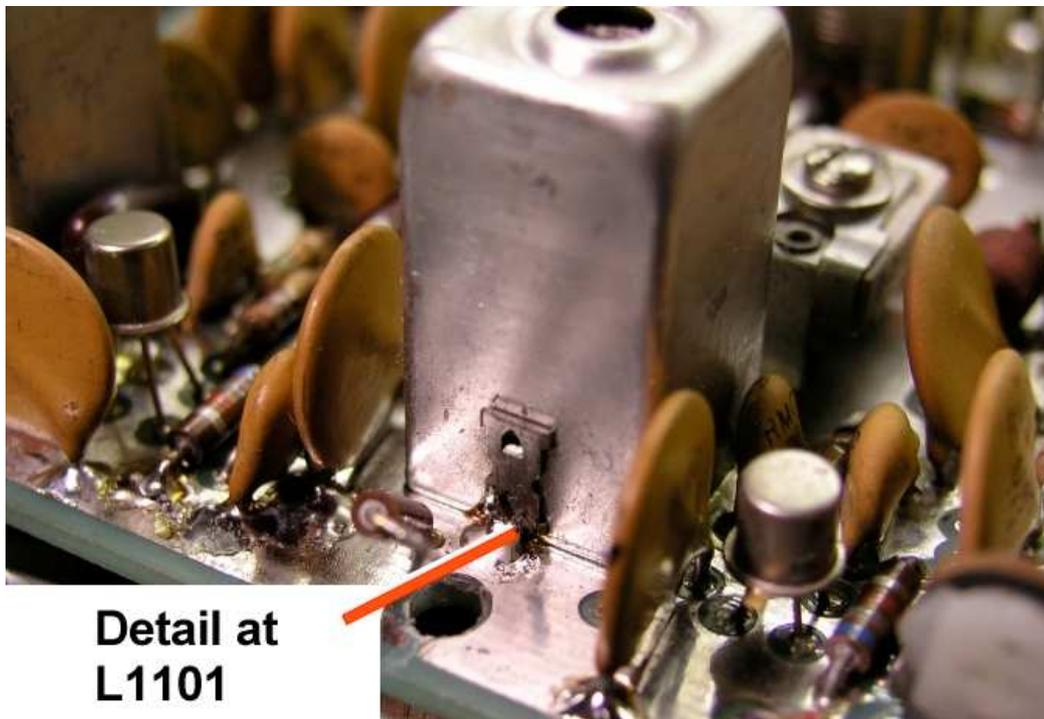
Picture 4: Groundconnection at L1101 (Detail)

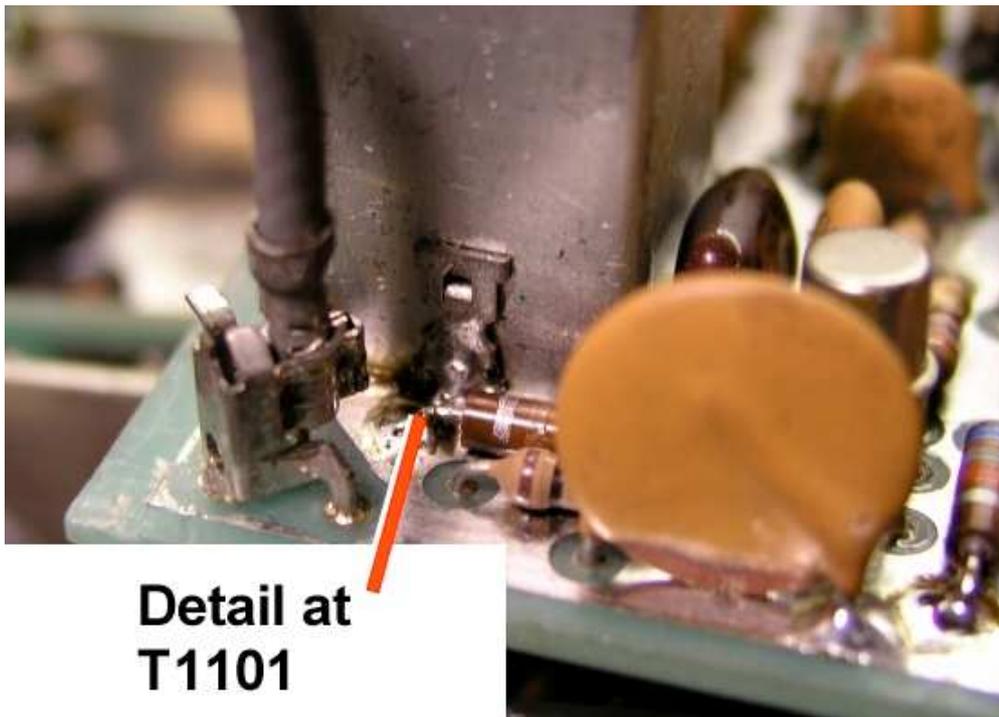
Picture 5: Groundconnection at T1101 (Detail)

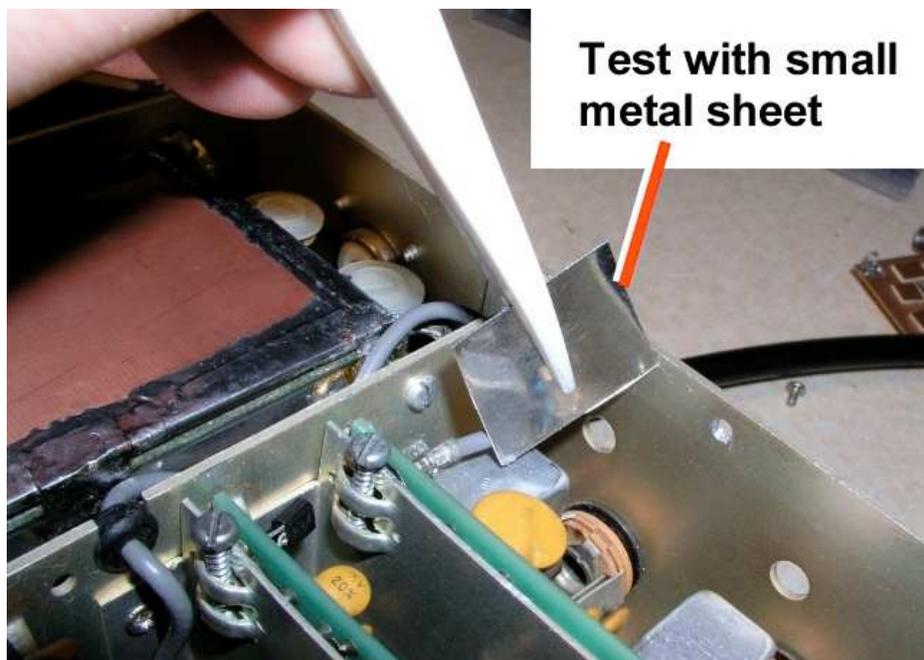
Picture 6: Test at the inputstage T1101

Some tests showed, that additional grounding of the inputstage T1101 improved the situation considerably. With a small metalsheet, moved around with a plastic-tweezer, the optimum place for the groundconnectin was found (picture 6) and realised there (picture 7). An additional screw gives a secure groundingpoint; remove the coating from the aluminum and use some lockwashers.

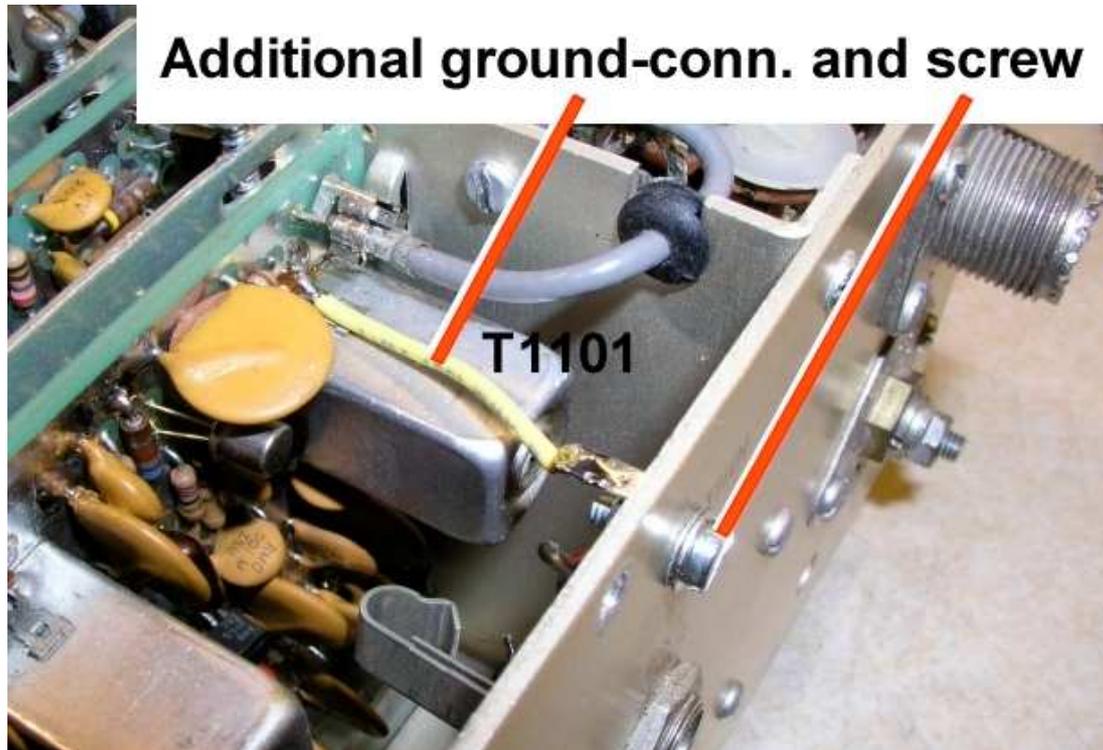
Picture 7: Additional grounding of T1101

With this step, the S-meter dropped down to nearly S0 even without the topcover in place!

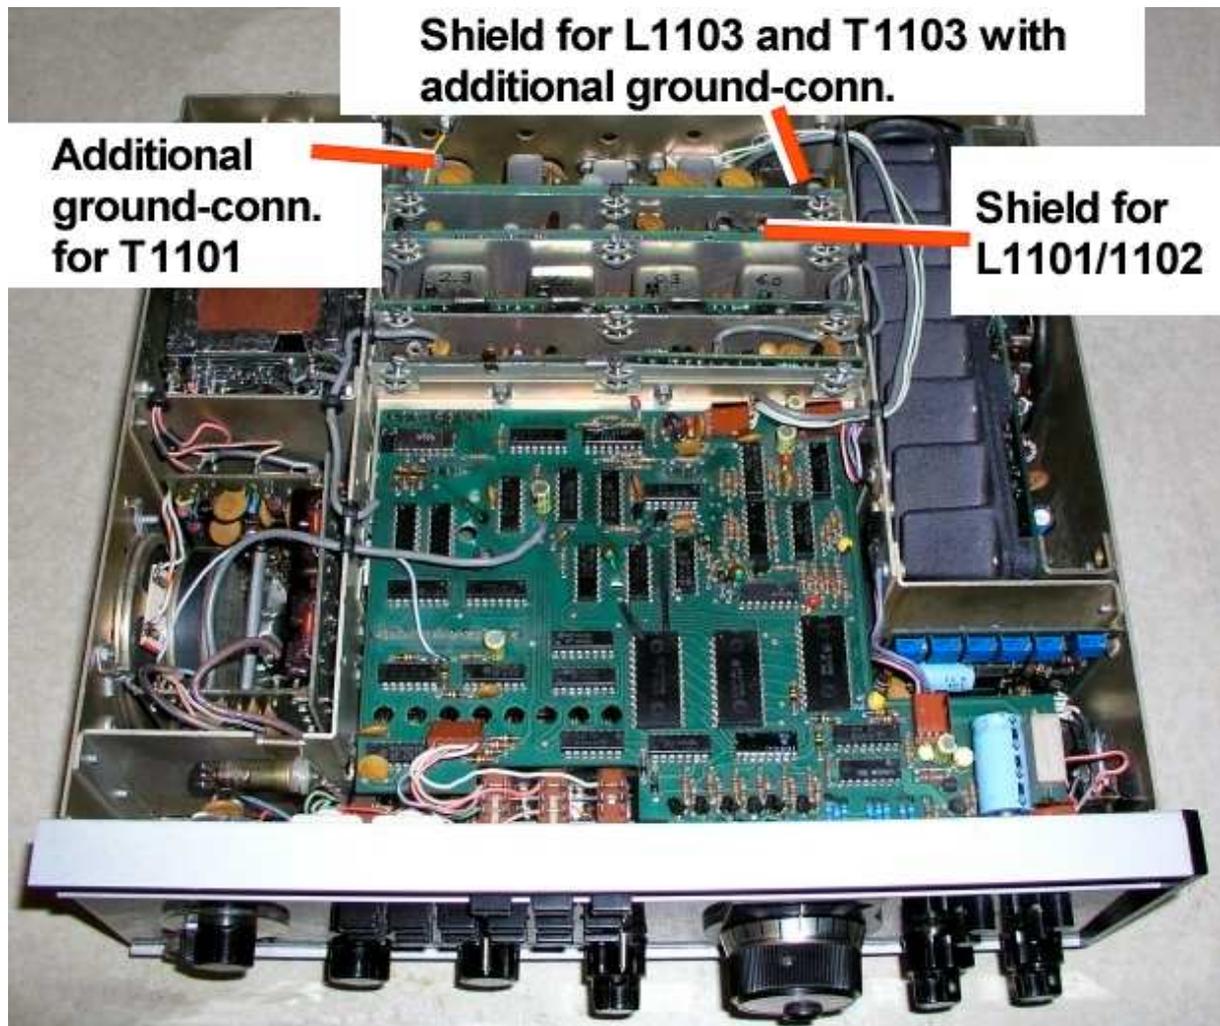
Picture 8 shows all modifications in my TR7 regarding this theme.

Picture 8: All modifications in one picture
