JRC NRD-535(DG) **Improved alignment for ECSS**

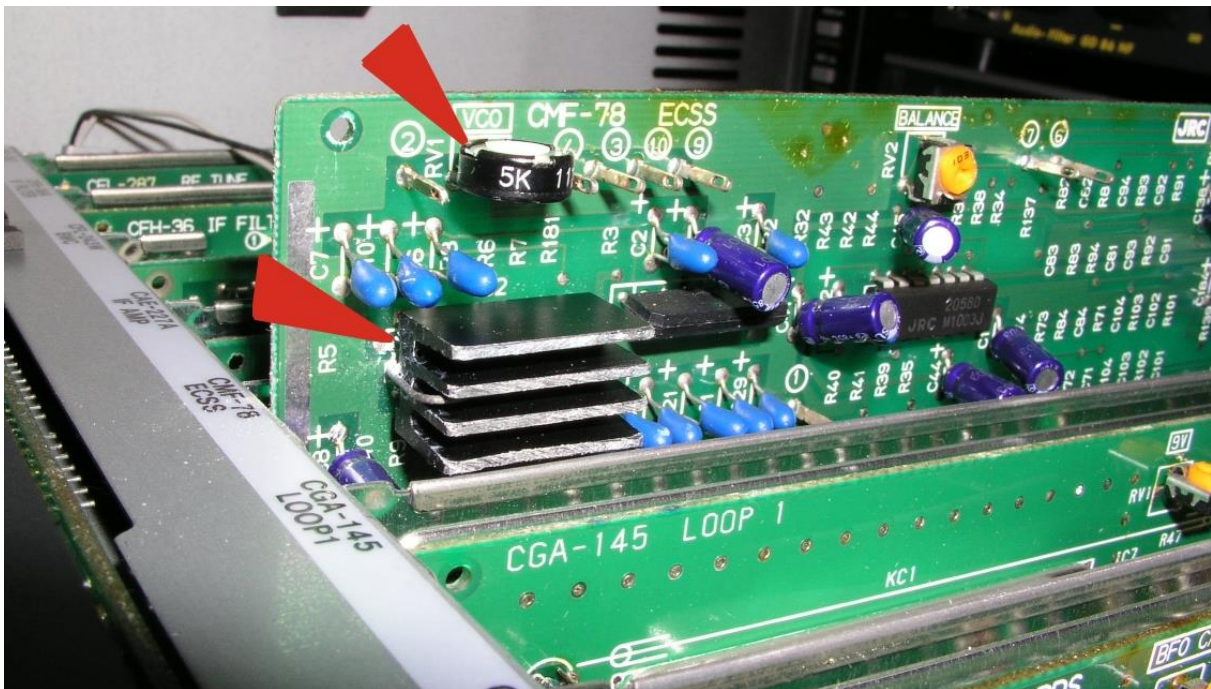
After some time of operation, I noticed that the stability of the alignment was better but wasn't as good as I had expected.

One reason is the thermal instability of the PLL-IC (IC2) MC14046, which has a power dissipation of app. 500mW(!) acc. to the data sheet. So it seems to be a good idea to use a small heat sink for DIP 16 ICs with a clip – see picture 1.

Picture 1: Heat sink for IC2 (PLL) and new trim pot RV1

Be careful with the clip, which has to be clipped under the IC, and avoid contact with the pcb and its wires. Had to cut the heat sink, because it was a little bit too high for the small space. A small drop of thermal grease will help. Hope this will increase the thermal stability. Additionally I replaced RV1 by a better one.
