Drake TR-7 - Full Output Power on 10m

My TR-7 (rather old unit; s-nr.: 1933) had only about 35W output on 10m, the other bands provided full output, i.e. more than 100W. A complete new alignment didn't improve the situation. Here are my proposals to improve the situation:

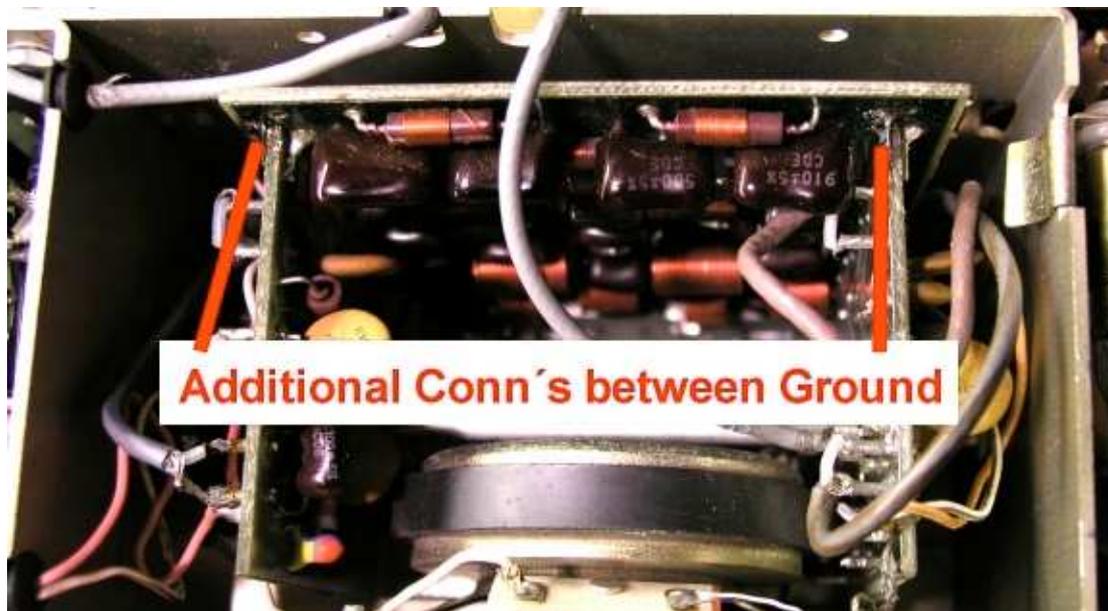
The HP- and LP-modules have rather few connections in the groundplane – especially the connections between the pcb's could be improved. There are only few pins in the ground-path, so i added additional copperstrips to improve the groundplane – see **pictures 4, 5 and 6**.

Picture 4: Additional groundconnections in the highpassmodule

A lot of work, but the result was not very effective: The output rose only by some watts.

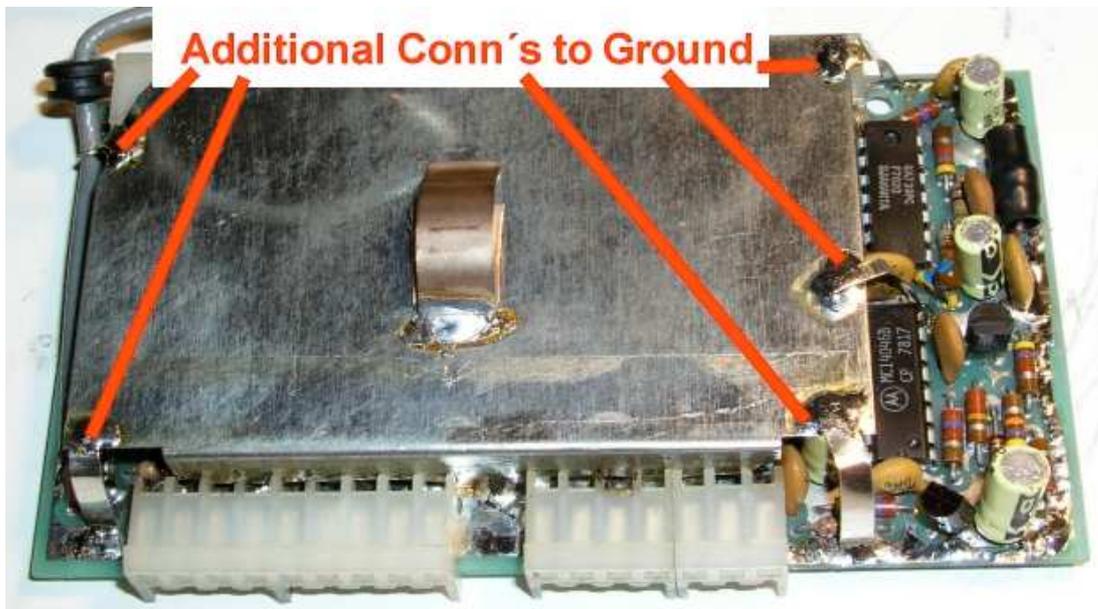
Picture 11: Shielding used as additional ground-layer

I resoldered all critical groundconnections of all components on the pcb's including the connectors. This required sometimes the unsoldering of other parts who hindered the access to the soldering points. Also additional copperstrips have been used for connections between top- and bottomlayer of the pcb's where necessary. Some examples are shown in the **pictures 8 to 11**.
