New Trim-pot´s for the Drake R-7

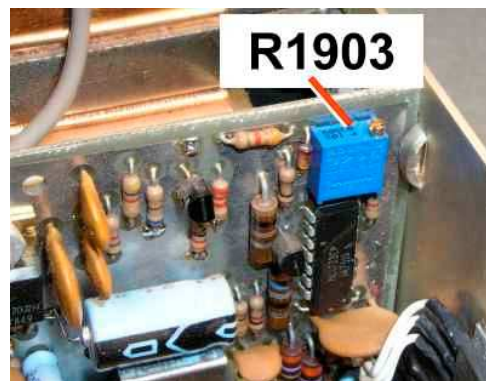
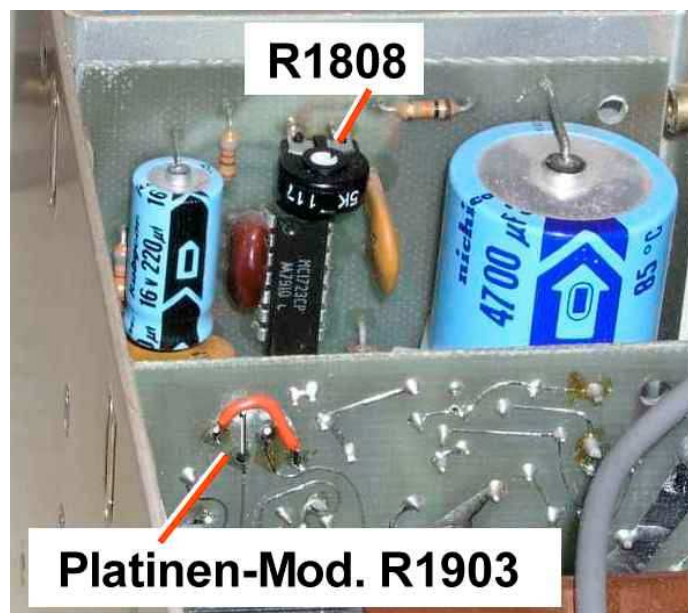
R1808: In my R7, the AF had sometimes a cracking noise. The reason was a small flutter of the stabilised 13,8VDC-supply. The variations where only about 100mV, but enough to be heard in the speaker. The reason was a intermittent trim-pot (R1808) on the 13,8VDC regulator board, which caused the flutter. This pot had to be exchanged.

R1903: Additionally R1903 (looked bad) on the power supply board was replaced as a precaution by a 10-gear pot. The pin-configuration of this new pot was different from the old pot, so the pcb had to be modified a little bit.

The pictures tell more than thousand words.....DON'T FORGET REALIGNMENT !
